Water Compliance Inspection Report

NPDES WAU 0000599

***NPDES
Inspection Report***

***Marmel Dairy
Everson, WA 98247***

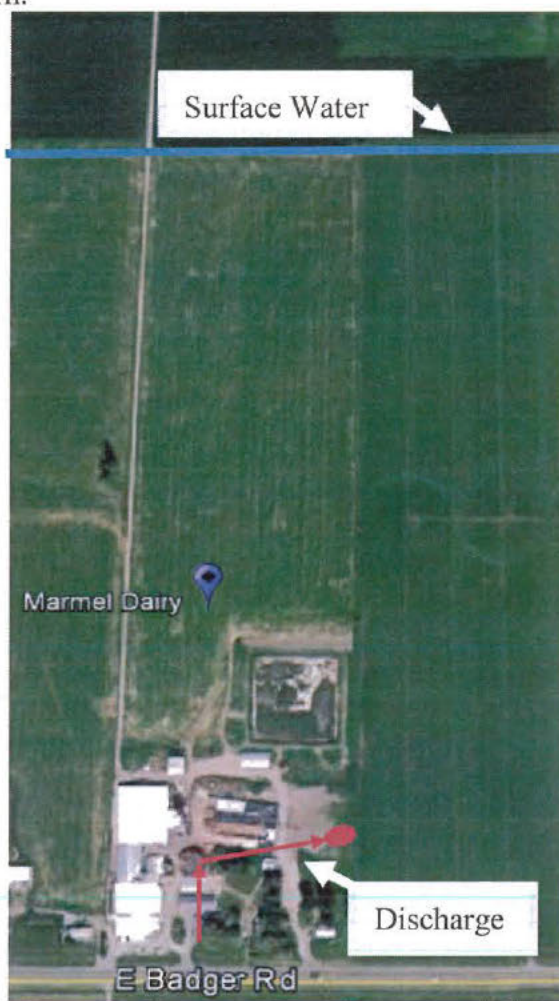
The nearest surface water from the grassy area is an unnamed ditch 700 yards to the north. I did not observe the discharge leaving the grassy area or field at the time of inspection. See Attachment A, Aerial Photo #4.

Aerial Photo #4: An aerial photo showing the flow pattern of the discharge identified in this report as an area of concern.

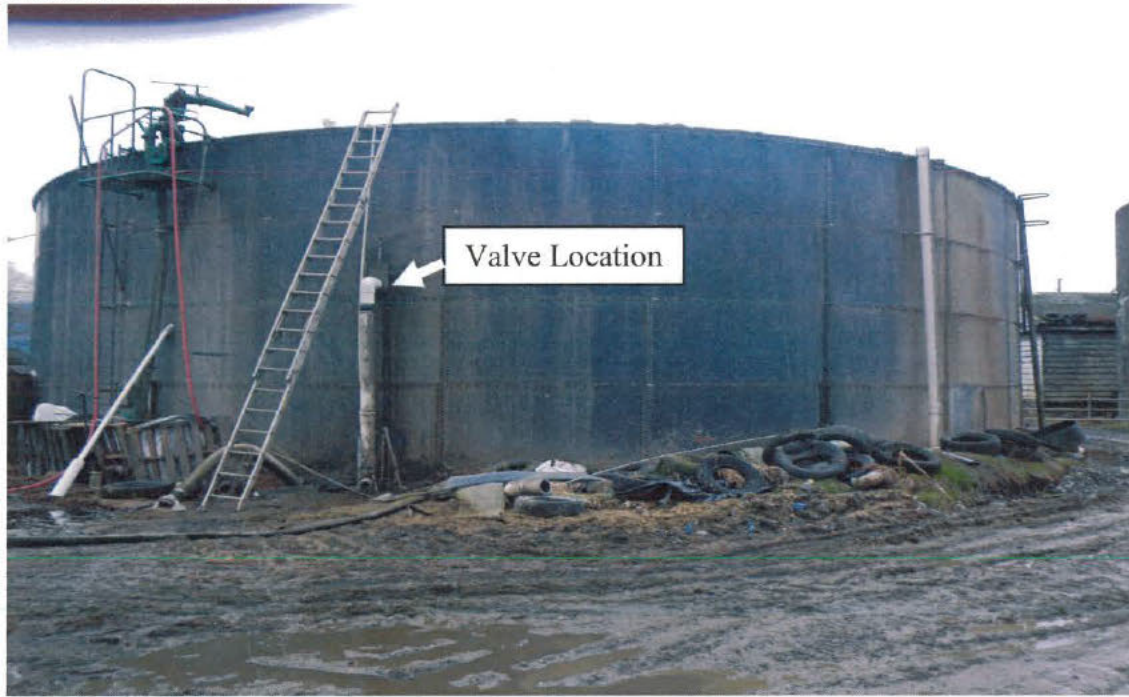
- A. Valve Blowout on the Above Ground Waste Storage Tank: At the time of inspection Mr. Jacklin stated that roughly two weeks prior to the inspection a valve on the facility's above ground storage tank became plugged and caused a minor overflow of the above ground storage tank.

Mr. Jacklin stated that shortly after the overflow, when attempting to fix the valve, the valve failed and liquid waste discharged from the tank at a high rate to the surrounding area. A catch basin located near the tank attempted to capture the overflow but failed due to the quantity and flow rate. A berm was then quickly constructed to contain the flow and also failed.

At the time of inspection it appeared that two weeks prior the manure discharged from the tank and traveled downslope to the north and around the silage storage area before settling in a grassy area and nearby field on the southwest corner of the waste storage lagoon. It appeared the manure had travelled roughly 600ft from the above ground storage tank. See Attachment B, Photo #1 – Photo #6.

Photo #1: Photo facing south, showing the above ground waste storage tank. The failed valve location is indicated.

Mr. Jacklin stated that the facility has repaired the valve and are planning to install a bypass line this spring that would allow the manure be routed back to the surge/flush tank to if the issue was to occur again.

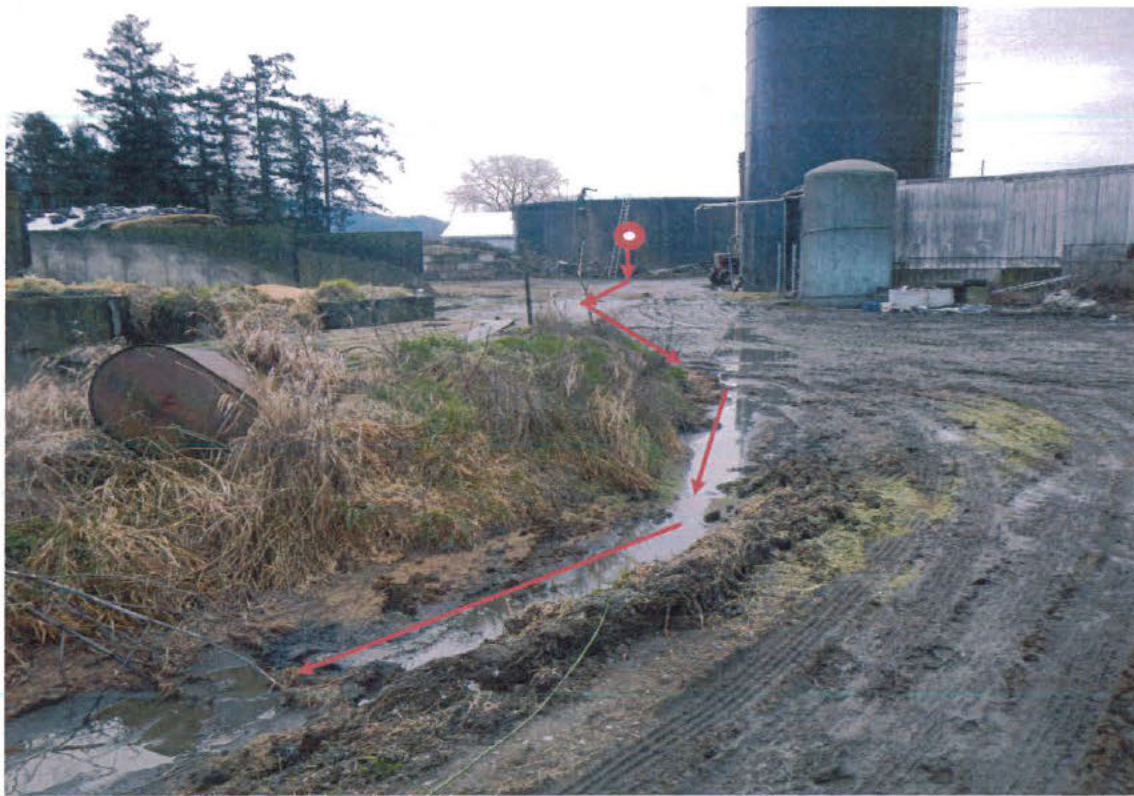
Photo #2: Photo facing south, taken from the northwest corner of the silage storage area showing the flow pattern of the discharge described by Mr. Jacklin.

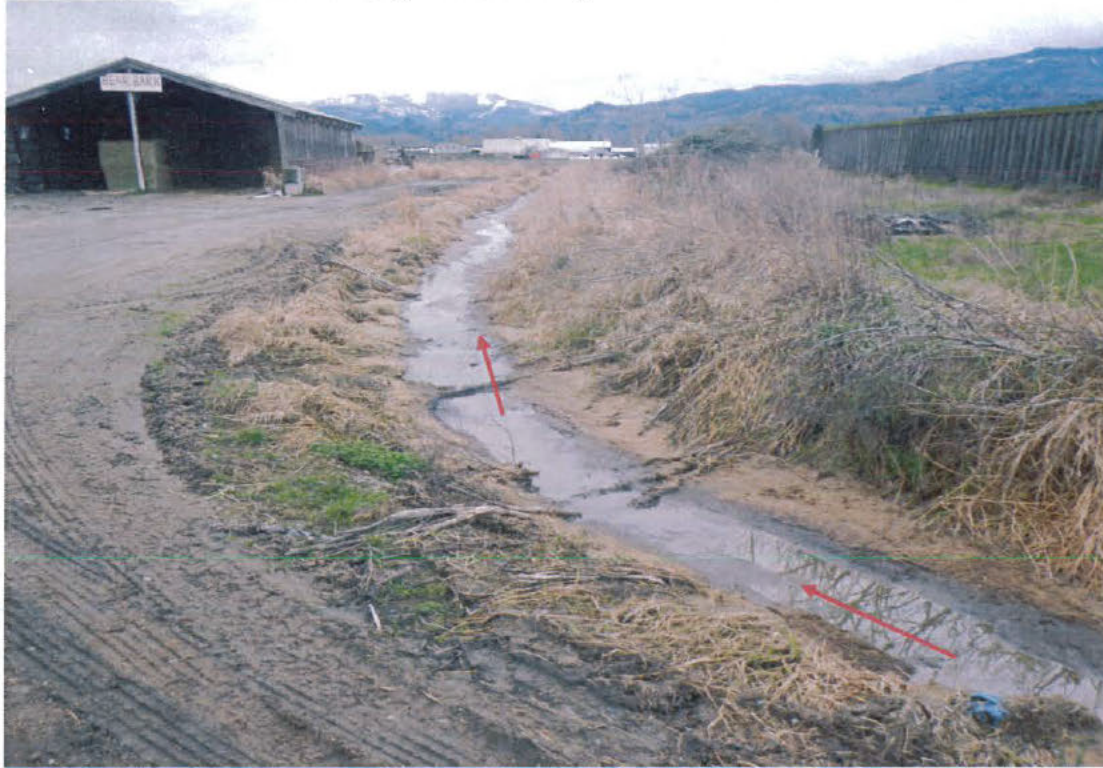
Photo #3: Photo facing east, taken from the northwest corner of the silage storage area showing the flow pattern of the discharge described by Mr. Jacklin continued from Photo #2.

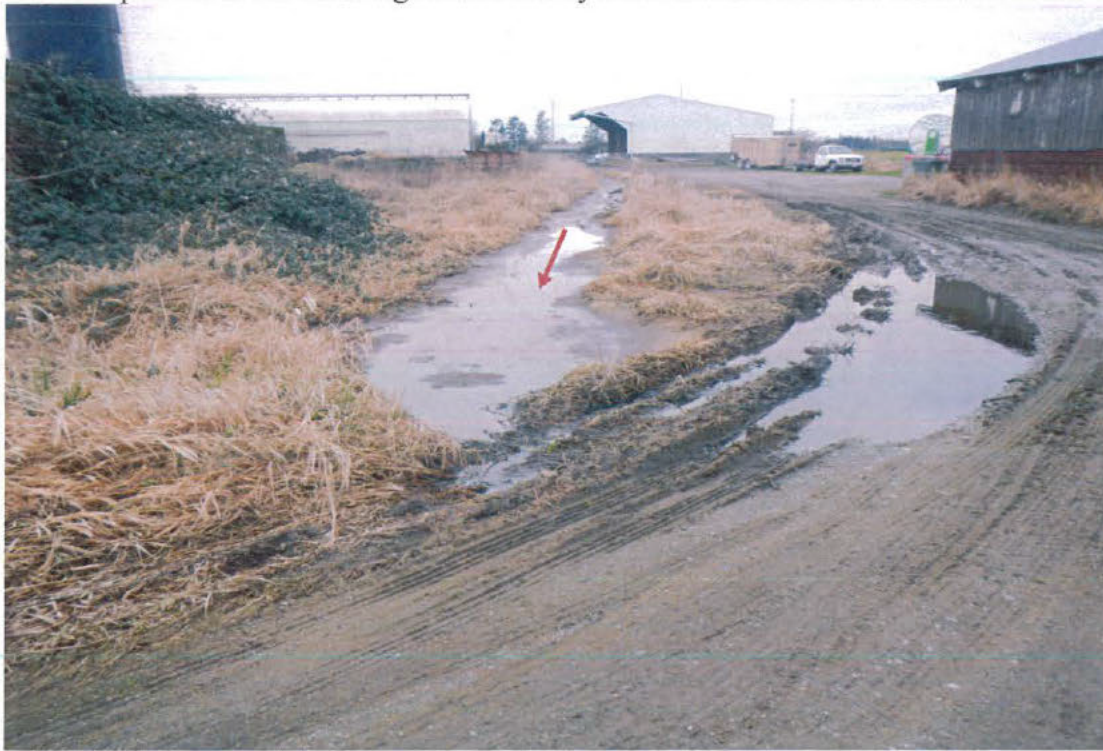
Photo #4: Photo facing west, taken from the northeast corner of the silage storage area showing the flow pattern of the discharge described by Mr. Jacklin continued from Photo #3.

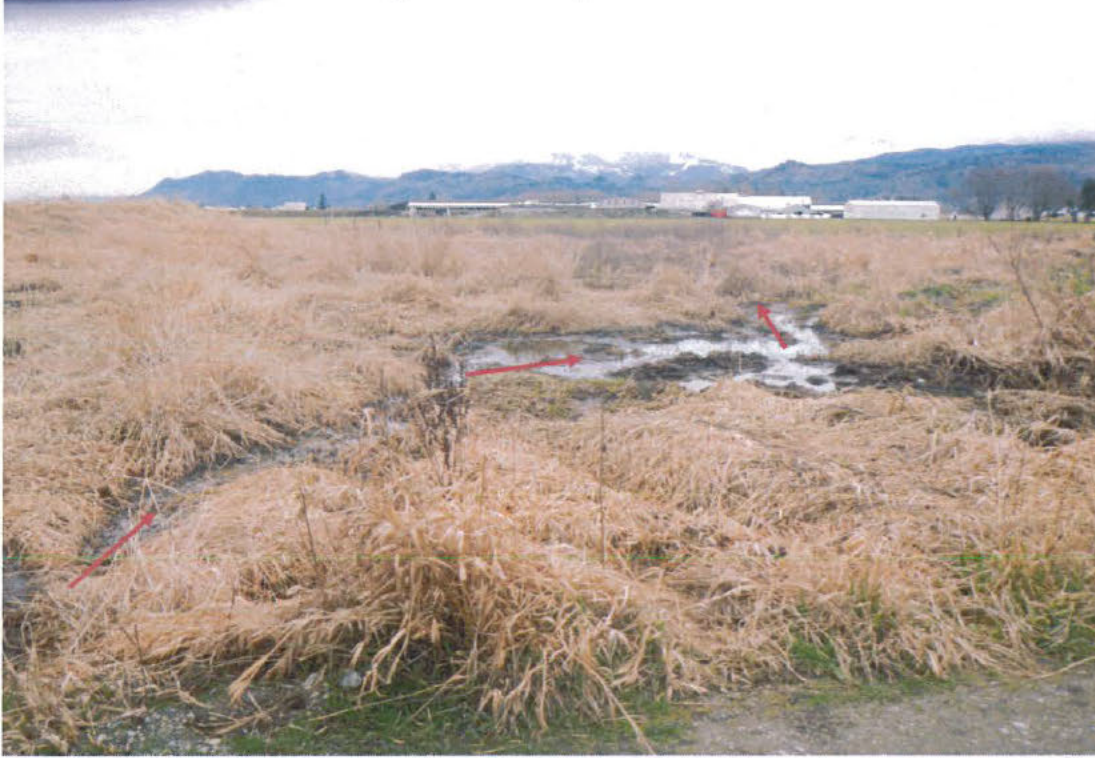
Photo #5: Photo facing west, taken from the northeast corner of the silage storage area showing the flow pattern of the discharge described by Mr. Jacklin continued from Photo #4.

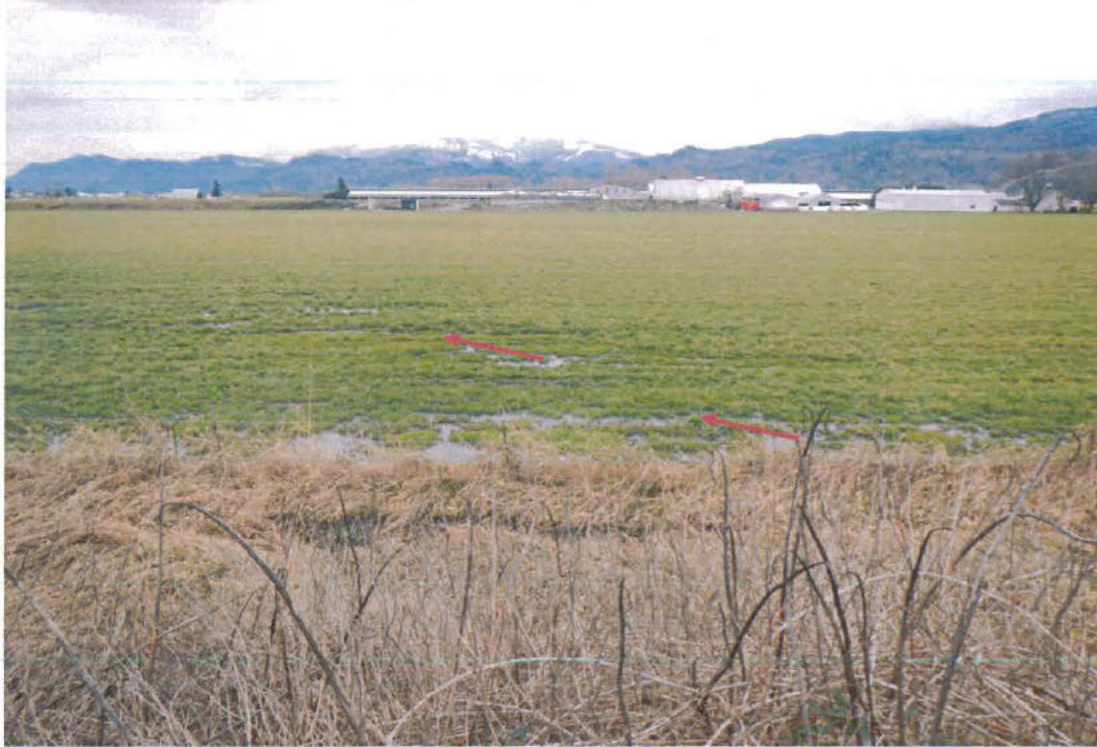
Photo #6: Photo facing west, taken from the northeast corner of the silage storage area showing the flow pattern of the discharge described by Mr. Jacklin continued from Photo #5.
